## **Limited Lead Paint Survey**

**Industrial Arts Building  
1800 State Fair Park Drive  
Lincoln, Nebraska 68508**

**Prepared by  
ATC ASSOCIATES INC.  
11117 MOCKINGBIRD DRIVE  
OMAHA, NEBRASKA 68137**

July 17, 2012

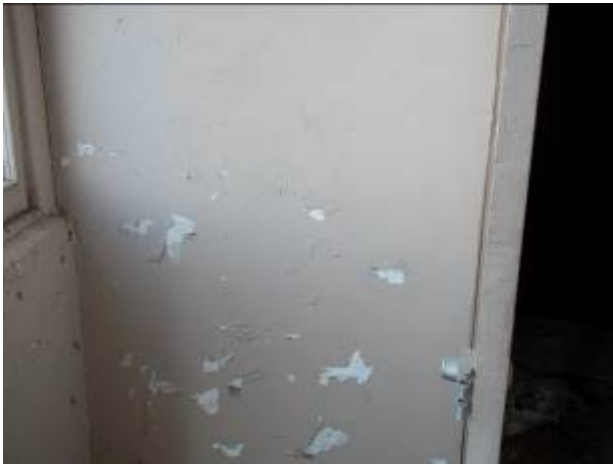
| <b>Component &amp; Location</b> | <b>XRF results<br/>(<math>\text{mg/cm}^2</math>)</b> |
|---|---|
| Brown Concrete Wall, Side B, Southwest Entry | $1.0 \pm 0.1$ |

XRF Shot #141, Brown Concrete Wall, Side B, Southwest Entry

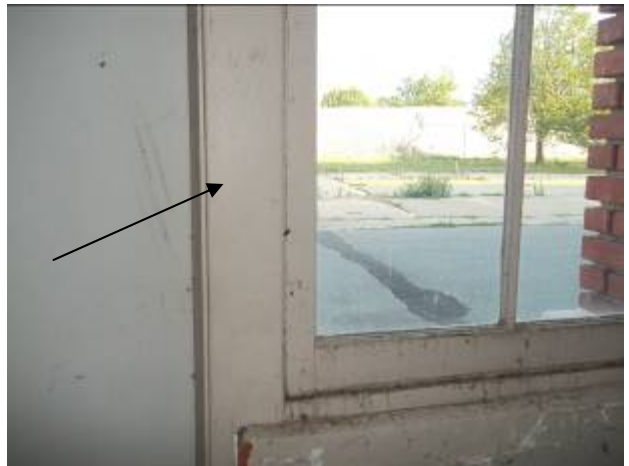
| <b>Component &amp; Location</b> | <b>XRF results<br/>(<math>\text{mg/cm}^2</math>)</b> |
|---|---|
| Brown Wood Window Casing, Side D, Southwest Entry | $4.8 \pm 3.4$ |

XRF Shot #143, Brown Wood Window Casing, Side D, Southwest Entry

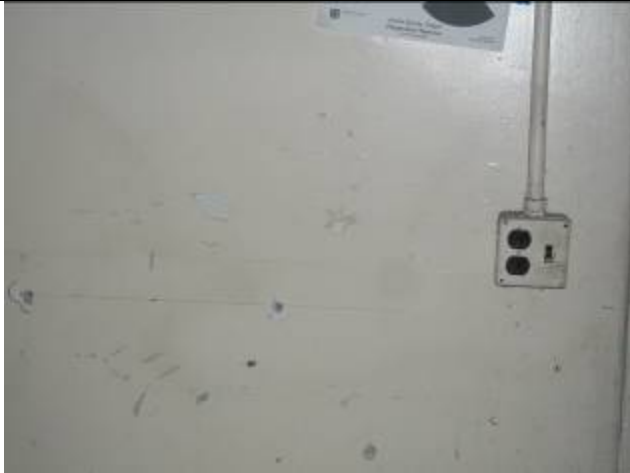
| <b>Component &amp; Location</b> | <b>XRF results<br/>(<math>\text{mg/cm}^2</math>)</b> |
|---|---|
| Brown Plaster Wall, Side C, Southwest Men's Restroom | $1.3 \pm 0.3$ |

XRF Shot #144, Brown Plaster Wall, Side C, Southwest Men's Restroom

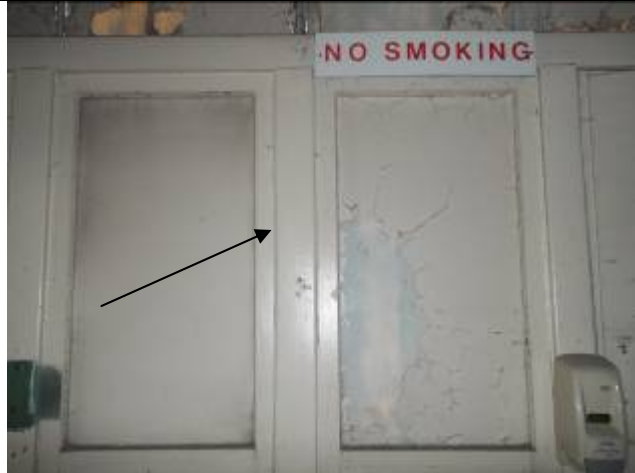
| <b>Component &amp; Location</b> | <b>XRF results<br/>(<math>\text{mg/cm}^2</math>)</b> |
|---|---|
| Brown Wood Window Casing, Side D, Southwest Men's Restroom | $3.8 \pm 2.7$ |

XRF Shot #151, Brown Wood Window Casing, Side D, Southwest Men's Restroom

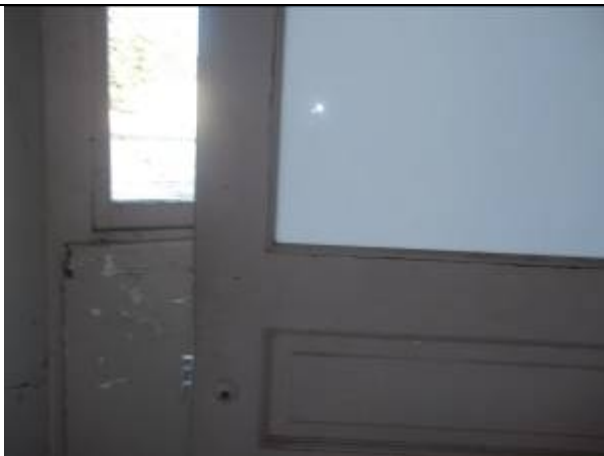
| <b>Component &amp; Location</b> | <b>XRF results<br/>(<math>\text{mg/cm}^2</math>)</b> |
|---|---|
| Brown Wood Door, Side C, Southwest Men's Restroom | $8.4 \pm 7.3$ |

XRF Shot #152, Brown Wood Door, Side C, Southwest Men's Restroom

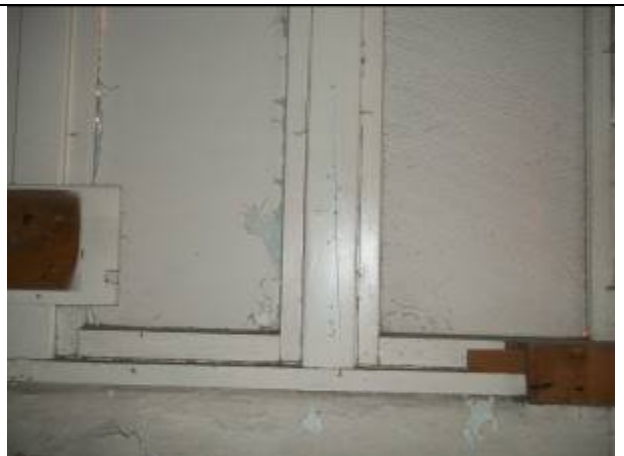
| <b>Component &amp; Location</b> | <b>XRF results<br/>(<math>\text{mg/cm}^2</math>)</b> |
|---|---|
| Brown Wood Window, Side B, Southwest Women's Restroom | $6.5 \pm 4.9$ |

XRF Shot #155, Brown Wood Window, Side B, Southwest Women's Restroom

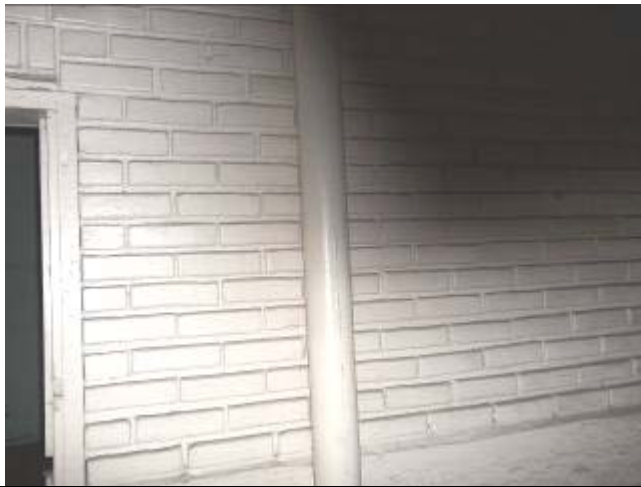
| <b>Component &amp; Location</b> | <b>XRF results<br/>(<math>\text{mg/cm}^2</math>)</b> |
|---|---|
| White Metal Pipe, Side A, Southwest Women's Restroom | $15.9 \pm 12.7$ |

XRF Shot #162, White Metal Pipe, Side A, Southwest Women's Restroom

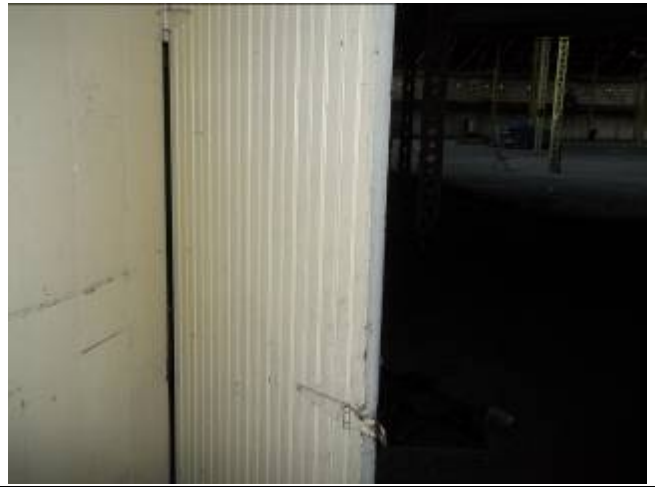
| <b>Component &amp; Location</b> | <b>XRF results<br/>(<math>\text{mg/cm}^2</math>)</b> |
|---|---|
| White Wood Door, Side B, Southwest Storage | $6.5 \pm 5.4$ |

XRF Shot #163, White Wood Door, Side B, Southwest Storage

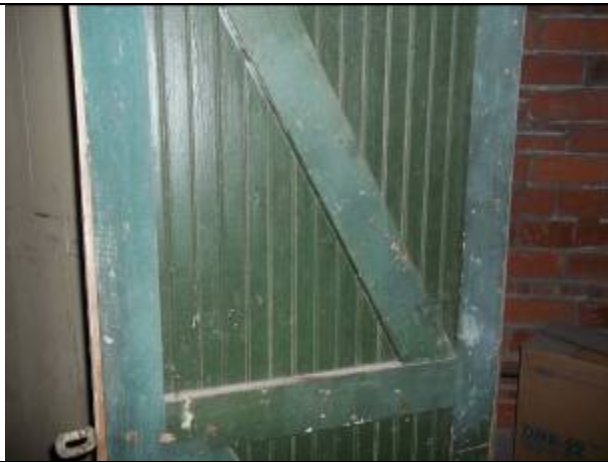
| <b>Component &amp; Location</b> | <b>XRF results<br/>(<math>\text{mg/cm}^2</math>)</b> |
|---|---|
| Green Wood Door, Side B, Southwest Storage | $4.4 \pm 2.7$ |

XRF Shot #164, Green Wood Door, Side B, Southwest Storage

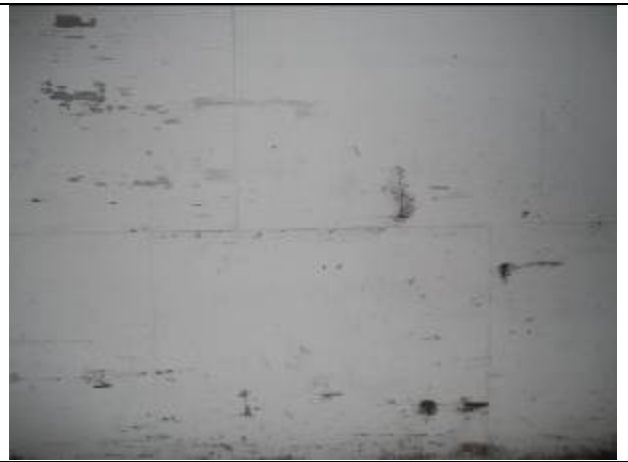
| <b>Component &amp; Location</b> | <b>XRF results<br/>(<math>\text{mg/cm}^2</math>)</b> |
|---|---|
| White Wood Wall, Side A, East 1 <sup>st</sup> Garage Area | $12.5 \pm 10.5$ |

XRF Shot #165, White Wood Wall, Side A, East 1<sup>st</sup> Garage Area

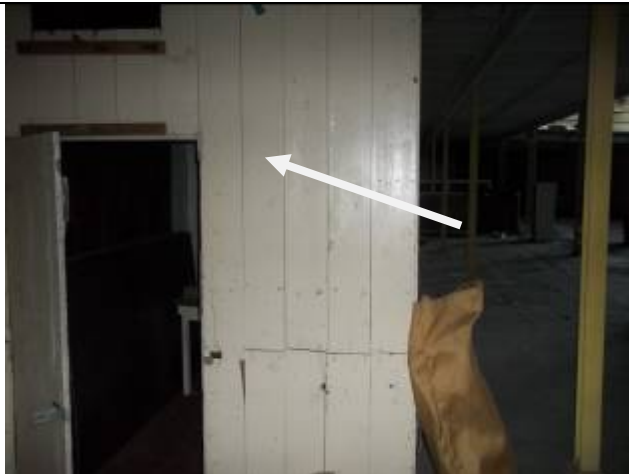
| <b>Component &amp; Location</b> | <b>XRF results<br/>(<math>\text{mg/cm}^2</math>)</b> |
|---|---|
| White Wood Wall, Side A, Middle East Storage | $1.2 \pm 0.1$ |

XRF Shot #167, White Wood Wall, Side A, Middle East Storage

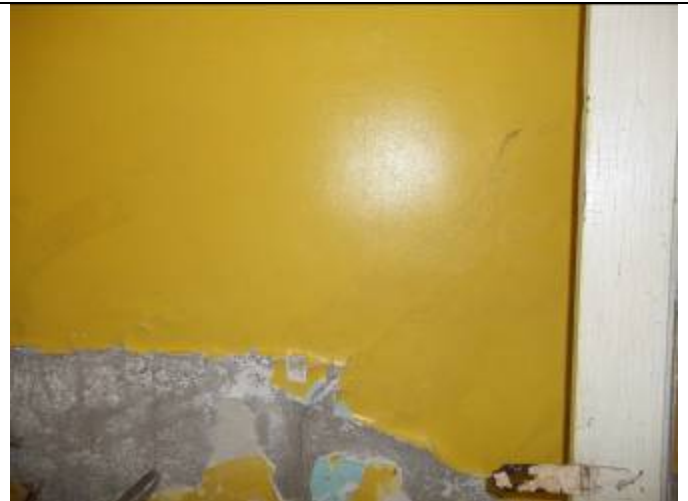
| <b>Component &amp; Location</b> | <b>XRF results<br/>(<math>\text{mg/cm}^2</math>)</b> |
|---|---|
| Yellow Plaster Wall, Side B, Northwest Office | $1.1 \pm 0.1$ |

XRF Shot #169, Yellow Plaster Wall, Side B, Northwest Office

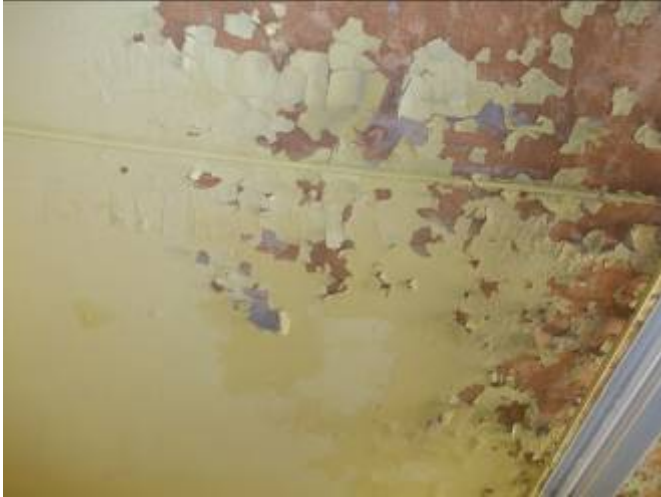
| <b>Component &amp; Location</b> | <b>XRF results<br/>(<math>\text{mg/cm}^2</math>)</b> |
|---|---|
| Light Yellow Plaster Ceiling, Northwest Office | $3.1 \pm 2.1$ |

XRF Shot #170, Light Yellow Plaster Ceiling, Northwest Office

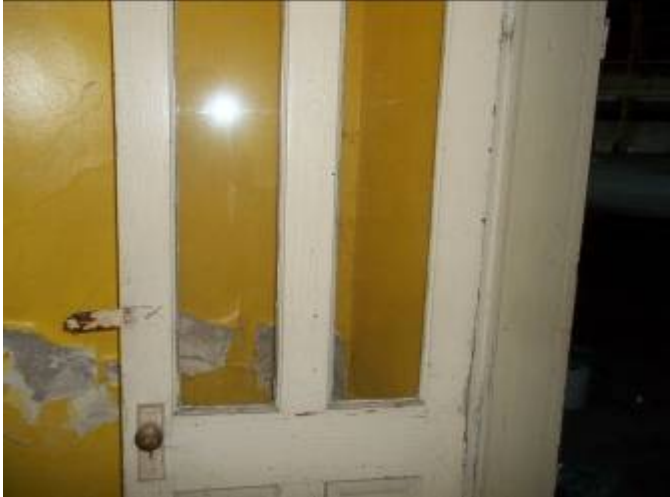
| <b>Component &amp; Location</b> | <b>XRF results<br/>(<math>\text{mg/cm}^2</math>)</b> |
|---|---|
| White Wood Door, Side B, Northwest Office | $21.3 \pm 18.6$ |

XRF Shot #171, White Wood Door, Side B, Northwest Office

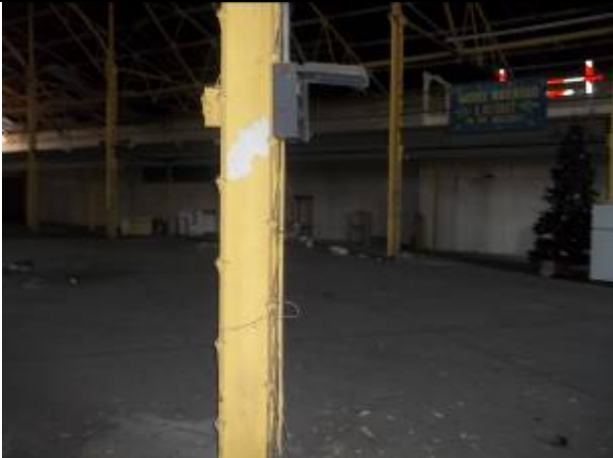
| <b>Component &amp; Location</b> | <b>XRF results<br/>(<math>\text{mg/cm}^2</math>)</b> |
|---|---|
| Yellow Metal Support Beam, Upper, Main Area | $7.0 \pm 5.9$ |

XRF Shot #177, Yellow Support Beam, Main Area

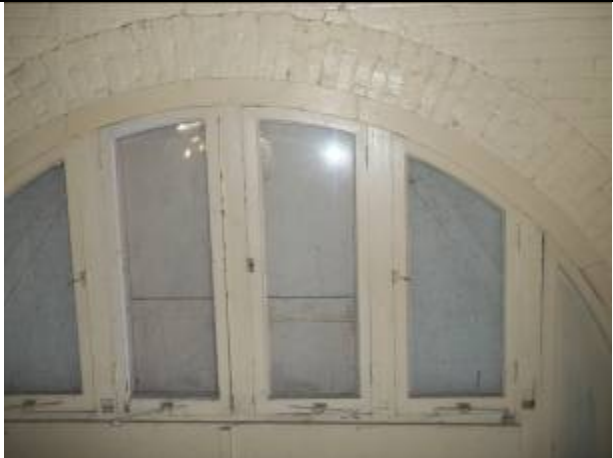
| <b>Component &amp; Location</b> | <b>XRF results<br/>(<math>\text{mg/cm}^2</math>)</b> |
|---|---|
| White Wood Window, Side A, Main Area | $6.2 \pm 4.3$ |

XRF Shot #184, White Wood Window, Side A, 2<sup>nd</sup> Floor Main Area

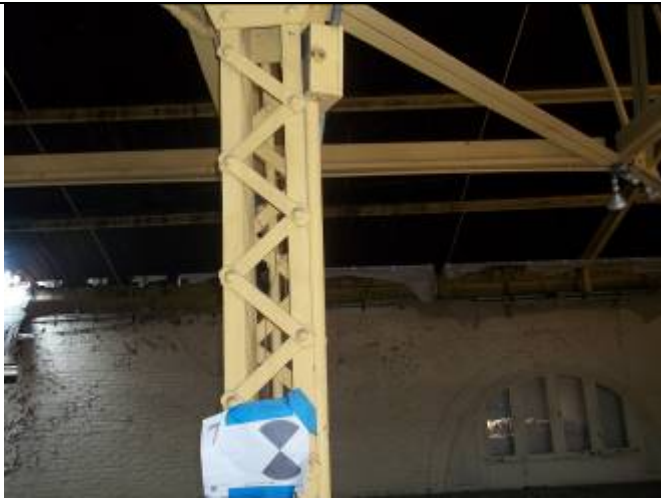
| <b>Component &amp; Location</b> | <b>XRF results<br/>(<math>\text{mg/cm}^2</math>)</b> |
|---|---|
| Yellow Metal Beam, Side A, Main Area | $10.4 \pm 9.4$ |

XRF Shot #185, Yellow Metal Beam, Side A, 2<sup>nd</sup> Floor Main Area

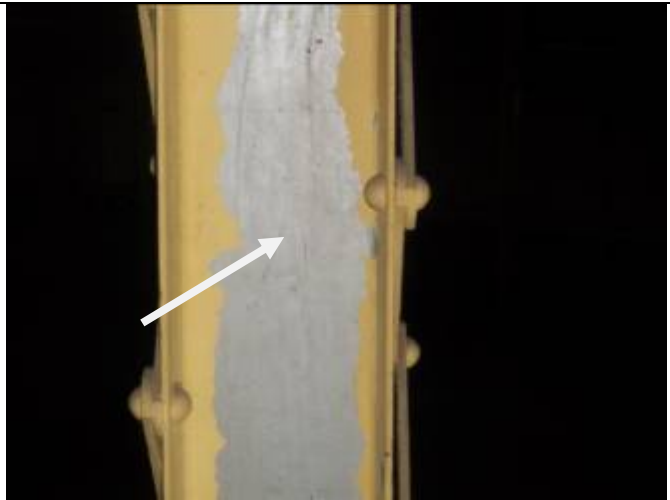
| <b>Component &amp; Location</b> | <b>XRF results<br/>(<math>\text{mg/cm}^2</math>)</b> |
|---|---|
| Silver Metal Beam, Side B, 2 <sup>nd</sup> Floor Main Area* | $9.5 \pm 7.9$ |

\*Paint Chip Analysis confirms lead is present in the paint layer and not in the metal.

XRF Shot #188, Silver Metal Beam, Side B, 2<sup>nd</sup> Floor Main Area

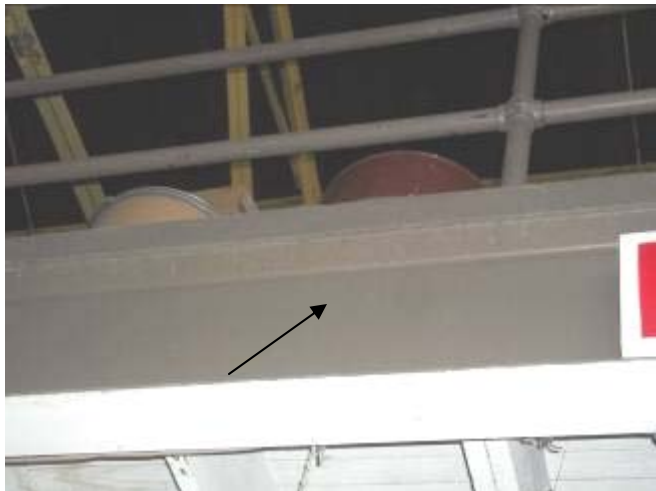
| <b>Component &amp; Location</b> | <b>XRF results<br/>(mg/cm<sup>2</sup>)</b> |
|---|---|
| Brown Metal Beam, Side C, Main Area | 10.7 ± 8.8 |

XRF Shot #190, Brown Metal Beam, Side C, Main Area

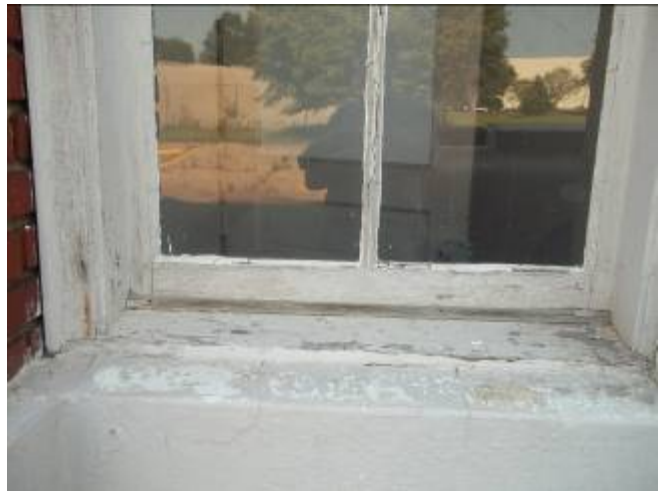
| <b>Component &amp; Location</b> | <b>XRF results<br/>(mg/cm<sup>2</sup>)</b> |
|---|---|
| White Wood Window, Side D, Exterior | 8.9 ± 7.9 |

XRF Shot #196, White Wood Window, Side D, Exterior

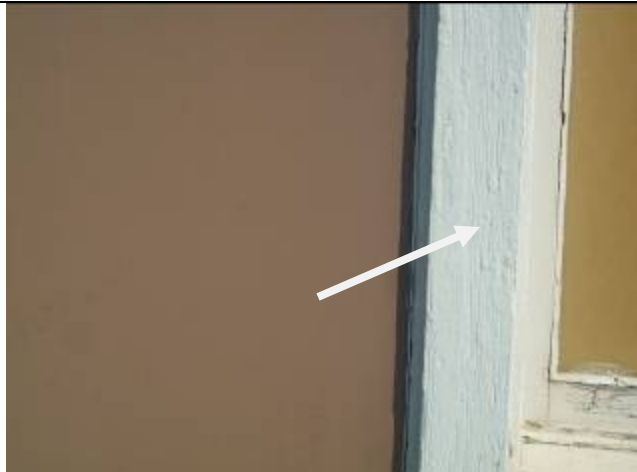
| <b>Component &amp; Location</b> | <b>XRF results<br/>(mg/cm<sup>2</sup>)</b> |
|---|---|
| White Wood Door Casing, Side C, Exterior | 4.2 ± 2.7 |

XRF Shot #199, White Wood Door Casing, Side C, Exterior

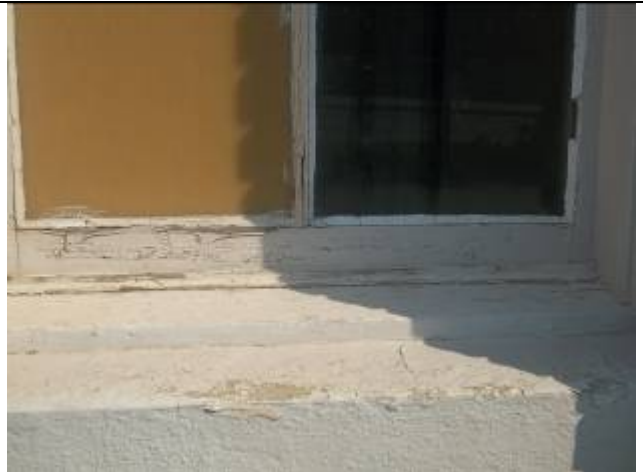
| <b>Component &amp; Location</b> | <b>XRF results<br/>(mg/cm<sup>2</sup>)</b> |
|---|---|
| White Wood Window, Side C, Exterior | 8.9 ± 6.8 |

XRF Shot #200, White Wood Window, Side C, Exterior

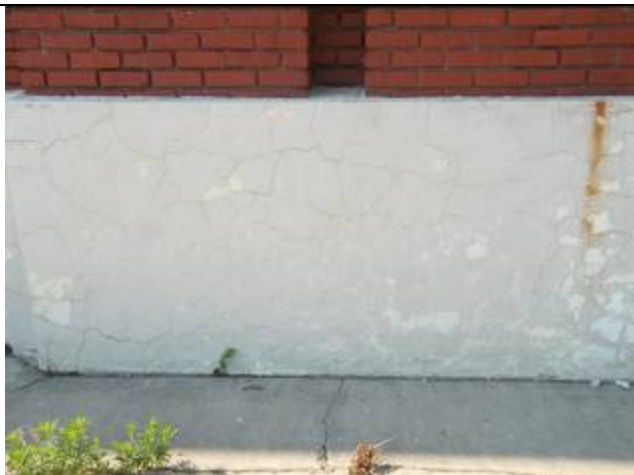
| <b>Component &amp; Location</b> | <b>XRF results<br/>(mg/cm<sup>2</sup>)</b> |
|---|---|
| White Concrete Wall, Side A, Exterior | 2.0 ± 1.0 |
| White Concrete Wall, Side A, Exterior | 1.3 ± 0.2 |

XRF Shot #210 and 211, White Concrete Wall, Side A, Exterior
